Swift Powerhouse No. 2

Catastrophic Failure of Swift No. 2 Power Canal Embankment occurred on April 21, 2002 following 42 years of operation. Shortly after the failure, Pillori Associates was engaged to investigate and determine the cause of the failure. Numerous borings and test trenches were performed within the canal basin and surrounding environs in addition to visual inspection of the damages and an extrusive review of construction and power plant operational records. Through the investigation, it was discovered that the canal basin was constructed over an ancient lava flow emanating from Mount Saint Helen. Native sand and gravel was formed beneath the basalt at varying depths and the canal bed and embankments were constructed on top of the basalt using materials from local burrow areas.

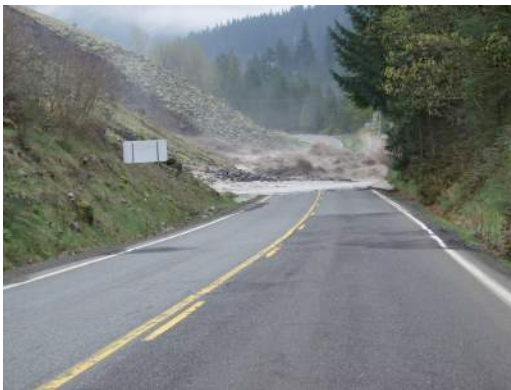
Canal Water Escaping Embankment Breach onto Local Highway

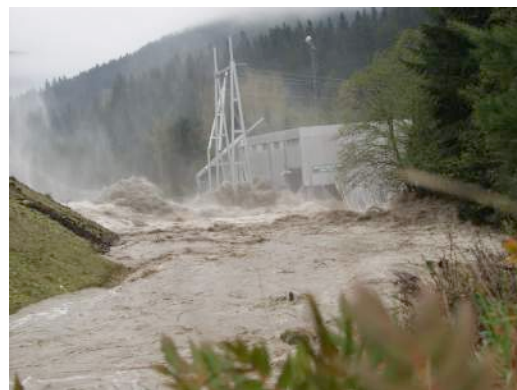
Canal Water Inundating Powerhouse and Local Highway

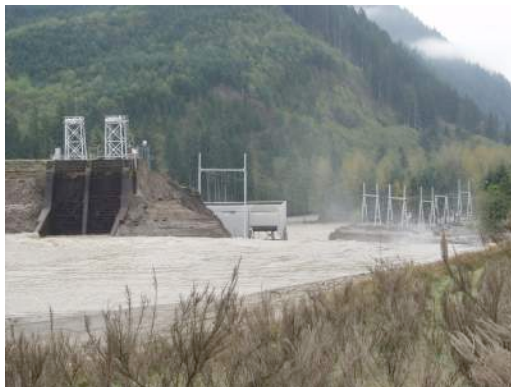
Canal Water Escaping Embankment Breach

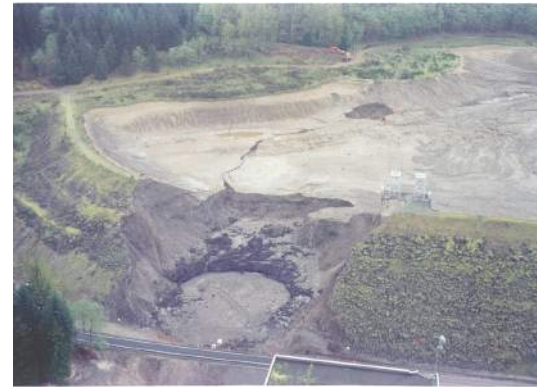
Analysis by Pillori Associates determined that the failure was caused by long-term erosion of the natural sand and gravel beneath the basalt layer. Over time piping channels starting near the powerhouse tailrace spread out under the basal, eventually finding the edge of the basalt within the canal basin. Once the connection formed, hydraulic pressures quickly ensued, causing a blowout of the basalt and a sudden catastrophic failure of the 90-foot high canal embankment.

Blowout Failure Under Canal Embankment-Empty Canal
