Conagua, Mexico

On April 4, 2010, a major earthquake (named El Mayor-Cuapah) hit near the Mexico-USA border registering 7.2 on the Richter scale. The quake caused widespread damage mostly resulting from liquefaction of the fine-grained surface soils prevalent throughout the region. Significant damages were reported by Mexico's National Water Commission (Conagua) to their District 14 "Rio Colorado" canal system, located in Mexicali, Mexico. Over 800 km of canal damage was reported. Pillori Associates was engaged by the insurance carriers to survey the canals and determine the extent and cause of the damage to the canal system.

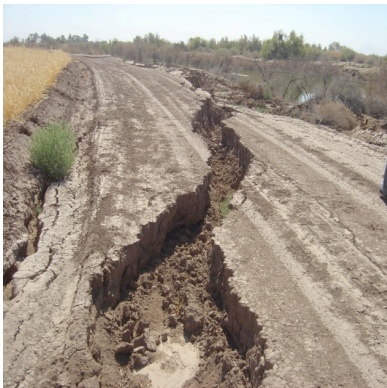
Large Ground Fissure Running Across the Road Near the Hardy River

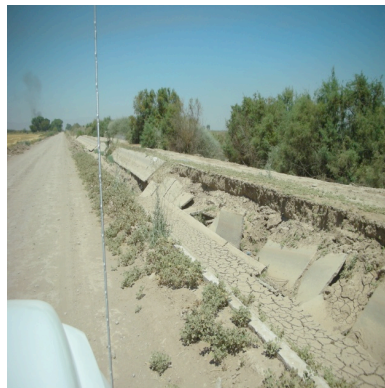
Sliding of Land Mass and Cast-in-place Concrete Liner Panels

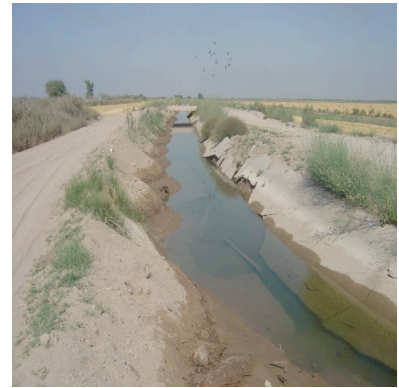
Liquefaction caused Undulating Surface along the Bank of the Canal in Unit 11

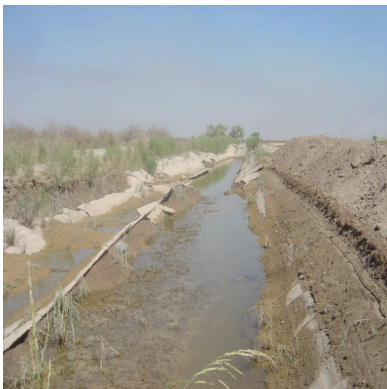
Lateral Spreading Caused the Concrete Panels to Slide and Buckle at the Toe in Unit 11

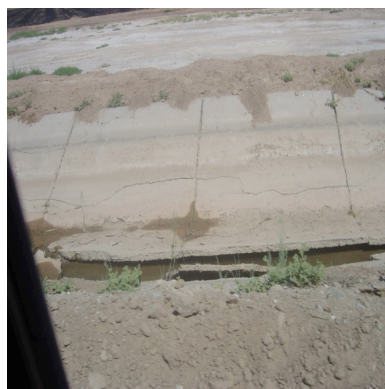
Liquefaction-induced Lateral Spreading Caused Flattening of the Side Slopes

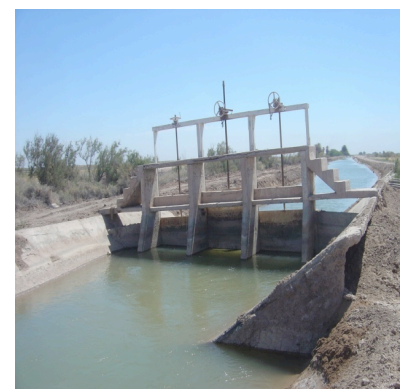
Lateral Displacement of Concrete Side Panel, Causing Tilting of Flood Gate in Unit 12
